Northern Railway SPAD CASES

Summary of SPAD cases over NR (2022-23, 2023-24, 2024-25)									
Div	Railway Reported			Division Reported			Grand Total		
	22-23	23-24	24-25 Upto Nov	22-23	23-24	24-25 Upto Nov	22-23	23-24	24-25 Upto Nov
DLI	0	0	0	0	2	0	0	2	0
FZR	0	0	1	1	2	1	1	2	2 (SJNP, RLS)
LKO	0	1	1	0	1	2	0	2	3 (KVG, BSB, AMS)
MB	0	1	0	3	1	0	3	2	0
UMB	0	0	0	4	2	0	4	2	0
DFCC	0	0	0	0	0	3	0	0	3 (SIRN & KRJN, RE)
Total	0	2	2	8	8	6	8	10	8

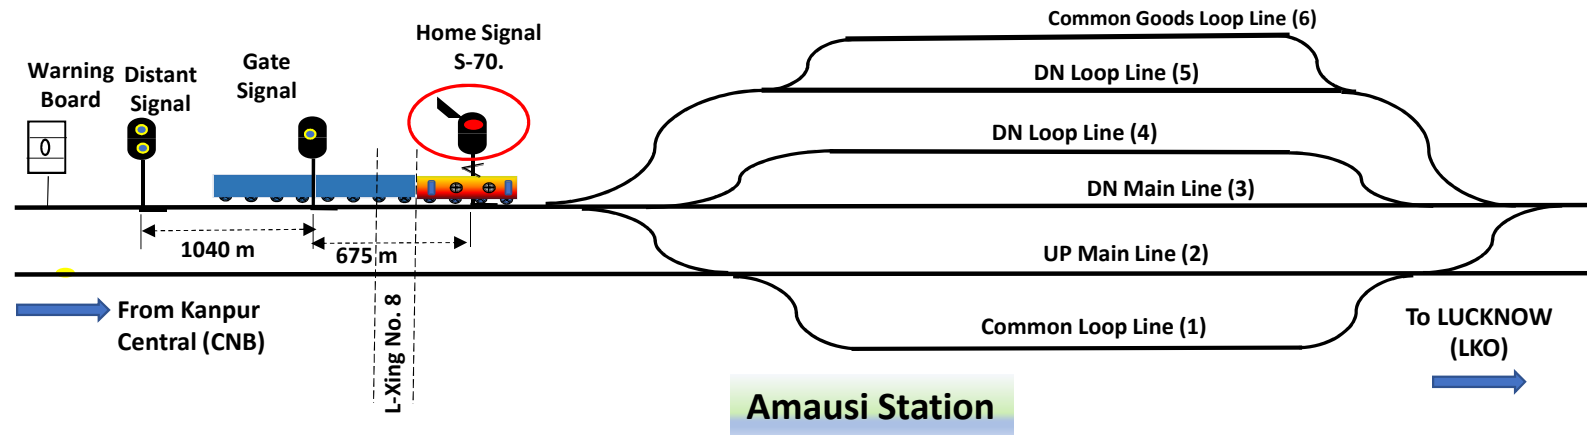
SPAD of Train No.15026 (ANVT-MAU), Loco 30242/GZB at Amausi (AMS) in LKO Division on 11.11.2024

- Section: CNB-LKO,
- Block section: POF-AMS
- Station: Amausi (AMS)
- Signal system- Color light on Double line in Absolute system.
- Last Signal sighting was done on 16/17.07.2024 between CNB-LKO by Signal Sighting committee.
- MV no 2114299/MAU/NER dated 10.11.24/LHB Rake/Load-22=44/BP-100% but as per Joint note BP found also 100% and validity 4000 km/36hrs.
- Continuity certificate no. 2116072 issued by ANVT /NR on date 11.11.24,
- Weather and Visibility was Clear.
- Total duty at time of SPAD-04'14''
- No Mandatory course of crew is overdue.

- LP Sign ON at CNB at 18.50 hrs after taking 03.51 hrs rest at CNB (out station).
- At 20.04 hrs train departed from CNB.
- At 21.16 hrs train passed PPF (Piparsand).
- Train was planned by traffic via South Line from AMS because DN/KV load was departing from North Line from AMS.
- Home Signal of AMS was kept in ON position for train 15026.
- At 21.20 hrs LP of train 15026 passed Home Signal of AMS in “ON” Position (RED) and stopped approx. 35 meters beyond home signal at 21:20:37 hrs.
- Loco pilot started back his train at 21:32:08 hrs and stopped before Home Signal at 21:32:50 hrs train after travelling 37 metres backward journey in 42 sec.
- LP passed gate signal at 67 kmph and at 21:19:51 hrs and passed home signal at 28 kmph at 21:20:28 hrs and speed became ‘0’ at 21:20:37 hrs (in 09 seconds).
- BA test of crew is found negative.

- At 21:20:37 train stopped approx. 35 meters beyond Homes after passing signal in ON position.
- At 21:32:08 hrs LP started back the train.
- At 21:32:50 hrs train stopped again after travelling 37 metres back in 42 sec.
- Distance between Warning Board and Distant Signal = 400 meters.
- Distance between Distant Signal and Gate Signal = 1040 meters.
- Distance between Gate Signal & Home Signal = 675 meters.
- Approx. speed of train while passing gate signal = 67 kmph (Time 21:19:51).
- Approx. speed of train while passing home signal = 28 kmph (Time 21:20:28).
- Speed became '0' at 21:20:37 hrs (in 09 seconds).

1. Speed of train was 67 at Distant Signal which was showing caution aspect.
2. Distant signal is also a Gate Signal which was forewarned by another Distant Signal, here also the speed was 67 kmph.
3. Crew did not reduce speed to 50 kmph while passing single yellow Gate signal.
4. After observing RED Home Signal, LP late applied brake and emergency brake was applied at 21:20:20 hrs at speed 46 kmph.
5. Crew was booked after taking 03.51hrs out station rest at CNB by NCR.
6. DN Home signal at km No. 11/32-32, and Gate Signal at km No. 12/16-18. There is a neutral section at km No. 12/24-26.

Cause of SPAD

As per JA grade Inquiry report:

- (a) Primary cause of accident is negligence of LPM Along with this, ALP did not take timely and sufficient action to stop the train when it passed the Yellow Gate-cum-Distant signal at high speed.
- (b) Equally responsible is the Crew Controller, CNB, Prayagraj Division, NCR for doing under-rest booking of LPM by using Rest Modification facility in Crew management system (CMS).
- (c) The role of nominated CLI in this SPAD is significant since he could have prevented the SPAD by being more proactive in his approach towards LPM who is a Category B' LPM.
- (d) Apart from this, under- rest crew booking by CNB Lobby could have been prevented if LKO lobby had timely sent spare crew to CNB Lobby.
- (e) TM/LKO is held blameworthy for failing to prevent push back of train no. 15026 without proper authority.

Action Taken: SF-5 issued on 26.11.2024 to LPM, ALP and CLI.

1. CLIs should be proactive in counseling their allotted LPs, especially the Category "B" LPs.
2. The guidelines regarding the use of Regenerative Braking must be brought out in clear terms indicating when/where to use and when/where not to use and the same must be included in CLI counseling.

3. The hand of ALP must automatically rest on RS valve on seeing a yellow signal. Counseling of ALPs in this regards needs to be effective and this must be checked through footplates and ambush checks.

4. In normal times, the booking of the crew should be done as per the link and the FIFO should not be resorted to for crew booking. In case of shortage of crew, higher management should intervene immediately to address the situation.

5. Although the provision for rest modification exists in CMS, it should not be resorted to by Crew controllers without proper authority and knowledge of higher officials.

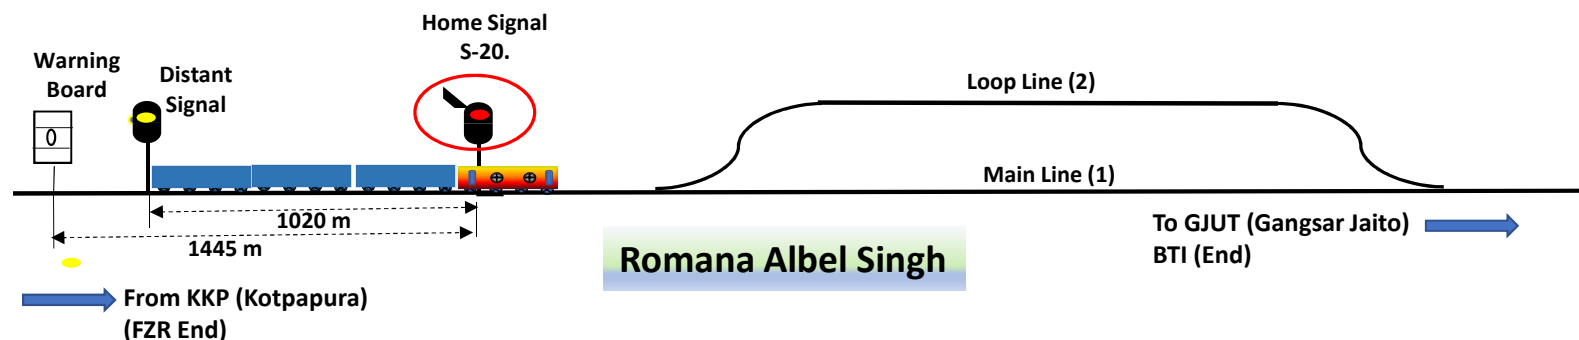
SPAD of DN FZP/UDB FG Load, Loco 49398/WDG-4/GIMB at Romana Albel Singh station in FZR Division on 17.11.2024

- MACL (Multiple Aspect Color light) Signalling territory on Single line in Absolute Block system.
- Signal Sighting was done 07.10.2024.
- Weather: Dense fog in section and Visibility was about 10-20 meters.
- Lime marking was available and fog signal post was painted.
- Total duty at time of SPAD: 03:44 hours.
- BA test of LP & ALP was done and found negative.
- No mandatory course of crew is overdue.
- FSD no.2/FZR was in working order.
- MV-5 no. 50000713503/KJGY/UMB/dt.08.11.24 (Validity 20+5 Days/Load: BCNL/42+BK-Van (3650Tonnes)).
- Brake power found 100% as per jointly checked.

- But LP of DN/FZP/UDB FG load stopped his train approx. 50 meters beyond passing home signal of RLS (Romana Albel Singh) in RED condition at 01:14 hrs.

- At 01:14:04hrs, after travelled 260 meters LP applied brake, BP dropped 4.79kg/cm² to 4.43kg/cm² and speed reduced (30kmph to 26kmph).
- At 01:14:04hrs, While train was approaching near Home signal S-20, FSD GPS network was not available resulted LP could not judge the distance of Home signal. Then suddenly, LP observed the Red Home Signal no.S-20 which was on curve (S-type-2.07 degree).

- At 01:14:14hrs, after travelled 79 meters LP applied Emergency brake at 26kmph (ALP also applied RS Valve).
- At 01:14:21hrs train passed Home signal of RLS (Romana Albel Singh) in RED condition at 22kmph speed.

- (1) LPG is held responsible for his lapses in not maintaining speed as per signal aspects, not taking a cautious approach in the foggy weather and belated application of brakes that led to passing DN Home Signal (S-20) of RLS station at "ON" position while working DN FZP-UD/FG on 17.11.2024. He violated the provisions of GR 3.78 (1) (a), GR- 3.80(1) of G&SR, Northern Railway.
- (2) ALP is held responsible for not showing necessary alertness in foggy weather and belated operation of RS valve that led to passing DN Home Signal (S-20) of RLS station at "ON" position while working DN FZP-UD/FG on 17.11.2024. He violated the provision of GR 3.78 (1) (a), GR-3.80 (1) of G & SR, Northern Railway.

1. Intensive and repeated counselling of running staff should be done regarding train working in foggy weather during winter season.
2. Intensive counselling of ALPs should be done to eliminate the hesitation to operate the emergency brake valve in case of emergency or in case loco pilots do not reduce the speed of train according to the aspect of signals or other obstructions.

3. Lobby in-charges and CC's to ensure proper functioning of FSD sets before issuance to the LP's
4. Simulator trainings for understanding of train dynamics, brake management to be conducted specially for Loco Pilots identified with poor driving techniques.

5. Availability of walkie Talkie sets in adequate numbers should be ensured, so that it is issued to each and every LP and TM.
6. Strict prohibition on usage of mobile phones by crew during journey needs to be ensured, unless in case of emergency as per guidelines.

7. The quality and effectiveness of the counselling by the CLIs need to be reviewed and improved.

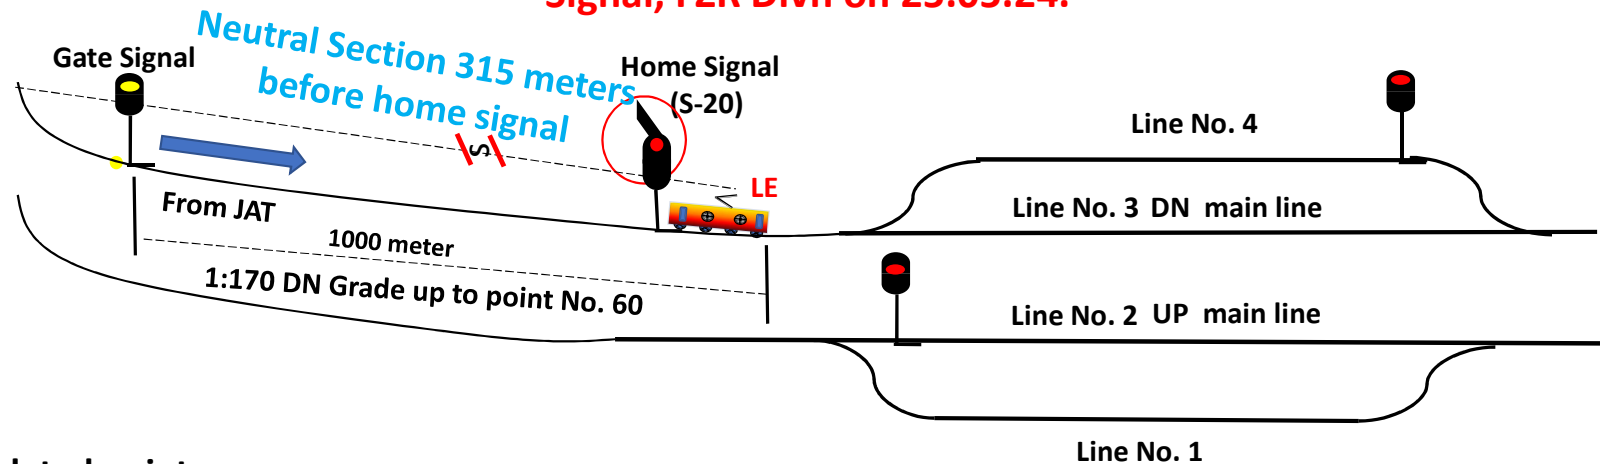
Detail of SPAD of Light Engine 43691/WAG-9, ET / WCR (New Loco from BLW 30.04.24) at SJNP (Sujanpur) Home Signal, FZR Divn on 25.05.24.

- Weather and visibility was clear.
- SJNP home signal clearly visible from more than 500 meters.
- There is neutral section at km No.06/22 which is located 315 meter before Home Signal No. S-20 and DJ close board is located at km No. 06/20.
- Distance between home signal No. S-20 and Gate signal is 1000 meters
- Down Gradient 1:170 upto point no.60 and then 1:400 in Yard.
- FSD & VCD was available in Loco and was in working order.
- Total duty-**05'07"** at the time of SPAD case.

- After clearance of line no.4, SM/SJNP while initiating the lowering of DN Home Signal S-20 for line no.4 (in between, at 11.12hrs LP passed SJNP DN Home signal S-20 at ON position and stopped after passing 31 meters and also back the loco) observed the Red indication on Panel. Then SM/SJNP immediately contacted on VHF set to LP of Light engine/PTKC and LP confirmed that he had passed Home signal at ON position by mistakenly.

- At 11.09.35hrs, Distant signal passed at **Double Yellow** aspect at 80kmph speed.
- At 11.10.40hrs, Gate signal passed at **Yellow** aspect at 80kmph speed.
- At 11.11.42hrs, DN Home Signal S-20 passed at **Red aspect** at 21kmph speed (as per data logger also),
- At 11.11.50hrs, LP stopped after passing DN Home Signal S-20 about 31 meters.

LP passed DN Hone signal at ON position due to brake late applied by LP as he was observing DJ closing on Neutral section

SF-5 issued on 25.06.24 to LPG, ALP CLI nominated as IO on 29.06.24 and D&AR inquiry submitted for further process.

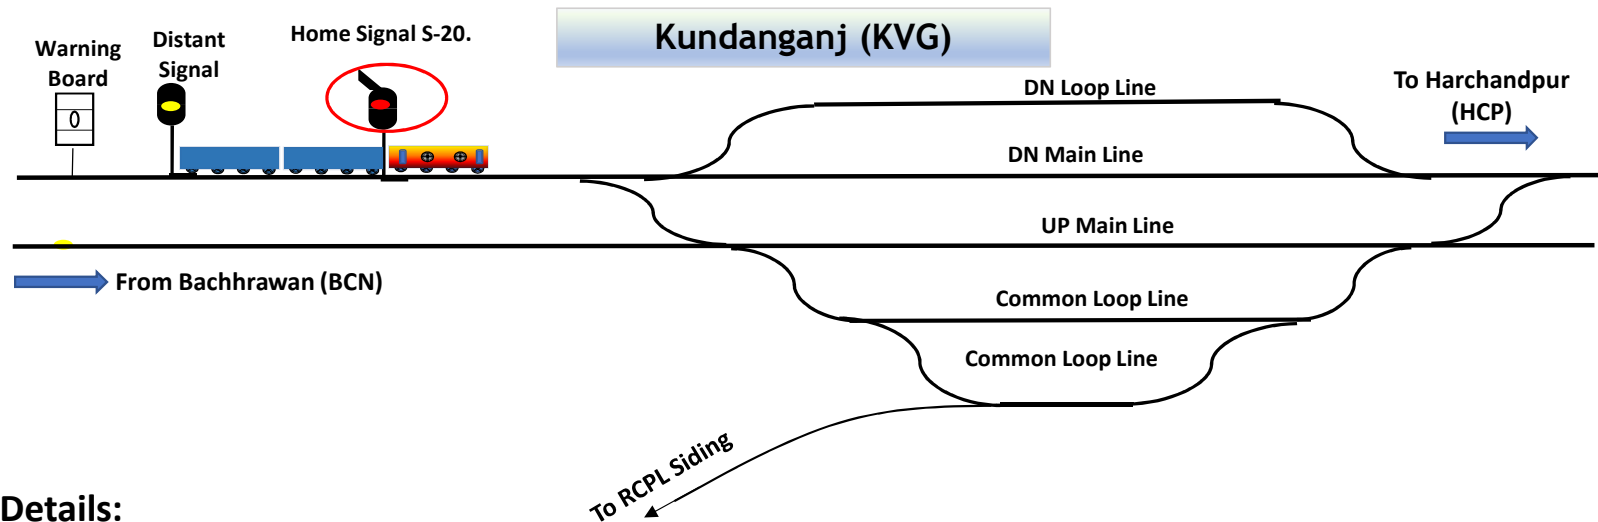
SPAD of BCNE load, loco DSL 12343 at Kundanganj (KVG), LKO Division on 09.08.2024

- Signaling system- Color light on Double line (UTR-RBL) in Absolute system.
- KVG DN Distant signal (A-20) and DN Home signal S-20 is on straight line and visibility of signals are clear.
- Weather was low rainy shower.
- There is gradient 1 in 725 as per SWR from DN Distant signal.
- MV-5 no.50000680439/FL/JP/NWR/dt.23.07.24/Valid for 12.08.24/Load-42+1/1600Tonnes/BP-100% and GDR prepared at CGS on 23.07.24/Valid till 02.08.24.
- Brake power of load with loco found 100% as per joint signatories.
- No any repair was booked in Engine log book.
- No Mandatory course of crew is overdue.
- Distance travelled 56kms (LKOY-KVG).
- Total duty at the time of SPAD incident -05'46''

- KVG DN Distant signal was at Single Yellow passed at 50.5kmph speed and DN Home signal no.S-20 was at ON position for DN BCNE, track was wet due to weather was low rainy shower, between DN Distant and Home signal LP applied brake before 207meters, speed reduced(46.1kmph to Zero) , speed was about 28kmph while passing DN Home signal, but LP stopped his train by Loco+ BK-Van after passing DN Home signal at ON position about 45 meters at 0.31.05hrs as per LP.

LP unable to stop his train before DN Home signal S-20 which was at ON position due to brake late applied by LP and said Signal could not be seen by ALP due to Loco was in long hood working and RS Valve did not operate by ALP.

Action Taken: (1) SF-5 issued on 23.08.24 to LPG, ALP and D&AR Inquiry is under process
(2) SF-11 issued to NCLI.

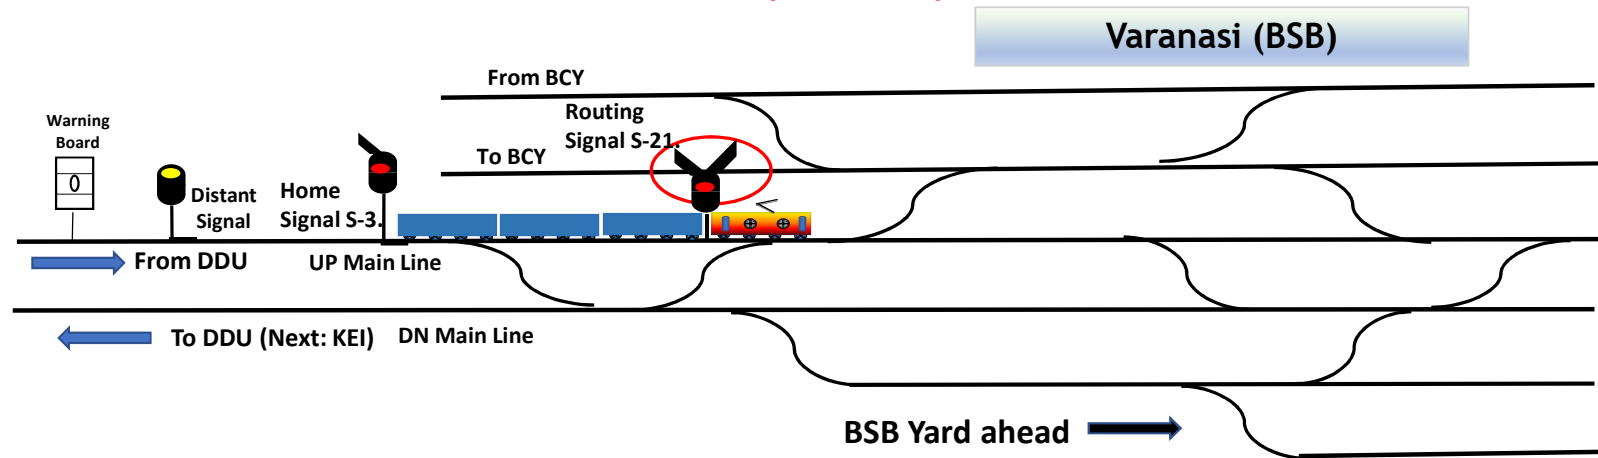
SPAD of UP/FGTP, Loco No. 34071 at BSB (Varanasi) station, LKO Division on 31.08.2024

- Signal no.S-3 and Routing signal no.S-21 is placed on straight line and visibility is OK and no any abnormality found regarding signal visibility.
- MV-5 no.50000682571/NKJ/JBP/WCR/dt.30.07.24 & Validity upto 02.09.24.
- UP FGTP Coal loaded-58+1BK Van (27 wagons conventional & 31 wagons BMBS)),
- Brake power of load with loco found 97.7% as per joint signatories.
- No any repair was booked in Engine log book.
- No Mandatory course of crew is overdue.
- Distance travelled 17kms (LKOY-KVG).
- Total duty at the time of SPAD incident: 02.07 hrs.

- After Calling ON signal which is provided on BSB/Signal no.S-3 became OFF train moved and was to be stop at Routing signal no.21 but LP after passing Signal S-3, at 13kmph speed BSB/Routing Signal no.S-21 passed at ON position and stopped at km no.771/35 at 0:55hrs at about 138 meters.

LP of Train no. UP FGTP load followed the aspect of Calling ON signal which is provided on Signal no.S-3 became OFF, train moved and was to be stop at Routing signal no.21 but LP after passing Signal S-3, Routing Signal no.S-21 passed at ON position and stopped at about 138 meters.

Action Taken:(1) SF-5 issued on 18.09.24 to LPG, ALP. Defense Reply from both COs is awaited.
(2) SF-11 issued on 18.09.24 to NCLI.

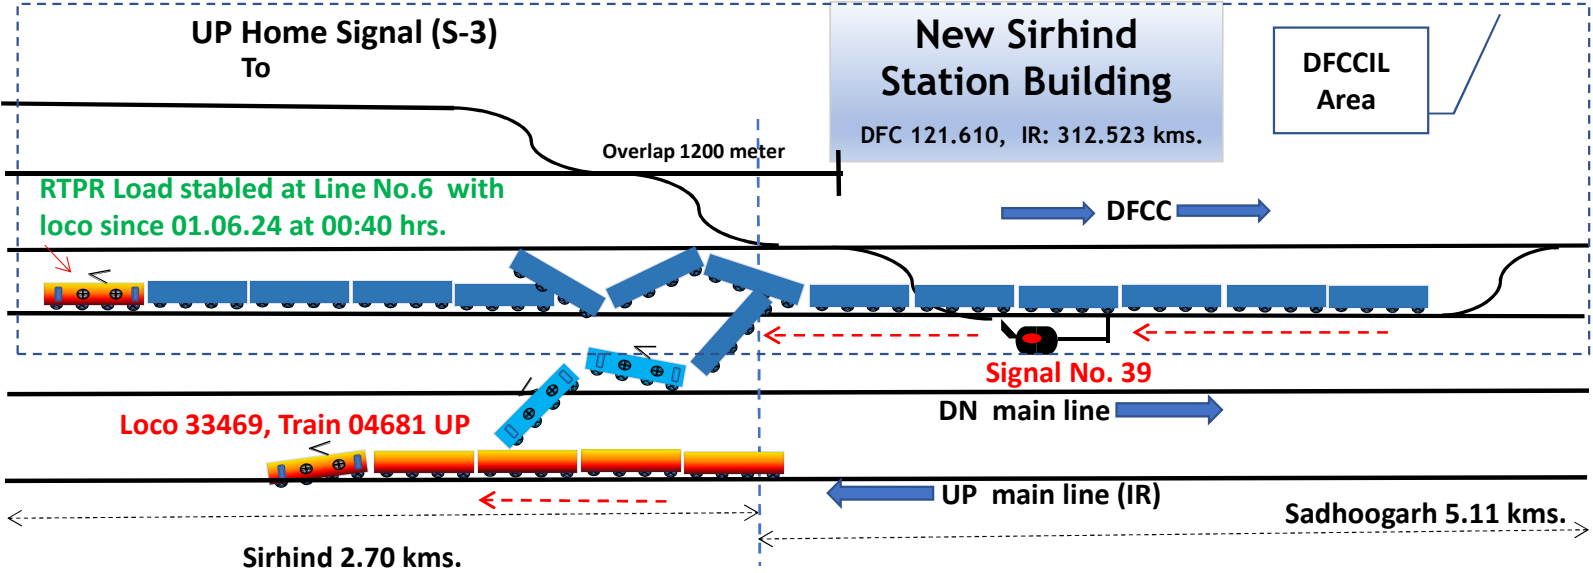
Collision & Derailment of loco no.33469/WAG9/CNB of Train no.04681 Exp between SIR-SDY on IR after SPAD of GVGN load, loco 60059/WAG-12/MELS at New Sirhind station (EDFC section) on 02.06.2024

Train no.14681 passed SDY on UP line at 03.14hrs on 02.06.24. while approaching to SIR Home Signal on Red aspect, side collision of loco no.33469/WAG9/CNB was occurred at km no.312/21-23, with Electric loco 60059/WAG-12B of GVGN load. This GVGN load is received on line no.6 of DFCCIL New Line Sirhind(NSIR) at 03.17hrs, at the same time OHE supply got tripped.

- LP of GVGN load passed Signal No. 32 on YELLOW aspect and at 03.15hrs LP supposed to stop at Signal S-39 which was RED but LP could not stop and passed signal at about 36 kmph speed in RED condition resulted collided with Brake Van of RTPR load which was stabled at line No. 6 resulting 9 wagons got derailed and Loco 60059/WAG-12B/MELS fouled UP and DN mail line of IR and collided with loco 33469/WAG-9/CNB, working in train No. 04681 UP which was coming from SDY (Sadhoo Garh) passed last signal A/S-809 (Automatic signal) with single yellow aspect the speed of train was Approx. 46 kmph and dashing leading trolley of loco derailed by all wheels.

- There was no S&T failure on IR track during the incident and Relay room was in closed position.
- As per data logger report of NSIR station and speedometer graph of loco no.60059, up GVGN LP passed Home signal S-1 in Yellow aspect with route indicator and not observed the Starter signal S-39 of line no.2 NSIR in Red aspect.

Conclusion: As per CRS Preliminary Report, Rear end collision of UP T.no.GVGN load with RTPR load at NSIR of EDFC and derailment of loco no.60059/SRE, 09 BOXNL of GVGN load and 04 wagons of RTPR load resulted in fouling of UP/DN M/Line of IR and collided with loco of T. no.04681 between SDY-SIR of UMB division is due to failure of Railway staff and system failures as follows:

- (1) Failure part of LP & ALP: Due to abnormal behavior and serious lapses exhibited by LP & ALP and finally disregarded the ON aspect of Intermediate Starter Signal S-39 and passed the signal at Danger causing rear end collision with stabled load RTPR on line no.6 at speed of 36kmph while running UP GVGN with loco no.60059/SRE.
- (2) Failure of other system at multiple levels which could have averted/reduced the extent of accident(VCD, Interlocking system at NSIR by DFCCIL, Yard layout provision of longer loop without isolation, SWR of NSIR for simultaneous reception)
- (3) Failure of staff in Train working(TM of UP GVGN load failed to maintain communication with crew, he did not perform duty as a overall in charge of train, SM not conversant with rule of SWR,TWR and OHE working, Section controller for poor management, NCLI for slack supervision

Responsibility :Loco Pilot & Asst. Loco Pilot. both did not observed Starter signal S-39 EDFC line no.2 in sleeping condition and passed it ON position resulted collision occurred .

SF-5 issued on 16.08.24 to LPG & ALP and removed from service.

1. Intensive monitoring of LPs/ALPs by NCLIs on DFC network, assessment of behavior, counseling and measure to ensure alertness of LP/ALP and it should be also ensured that one of LP should be not on continues night duty
2. VCD to be more effective taking all behavior aspect of LPs/ALPs
3. Route learning for loco crew operation on EDFC should be more strengthened and a special drive should be launched to impart route learning with special attention on signal position on longer loop to crew deployed on EDFC route.
4. Studies should be carried out on loco simulators with >6hours of simulated run to study changes/deterioration in crew behavior with hours of continues attention/duty.

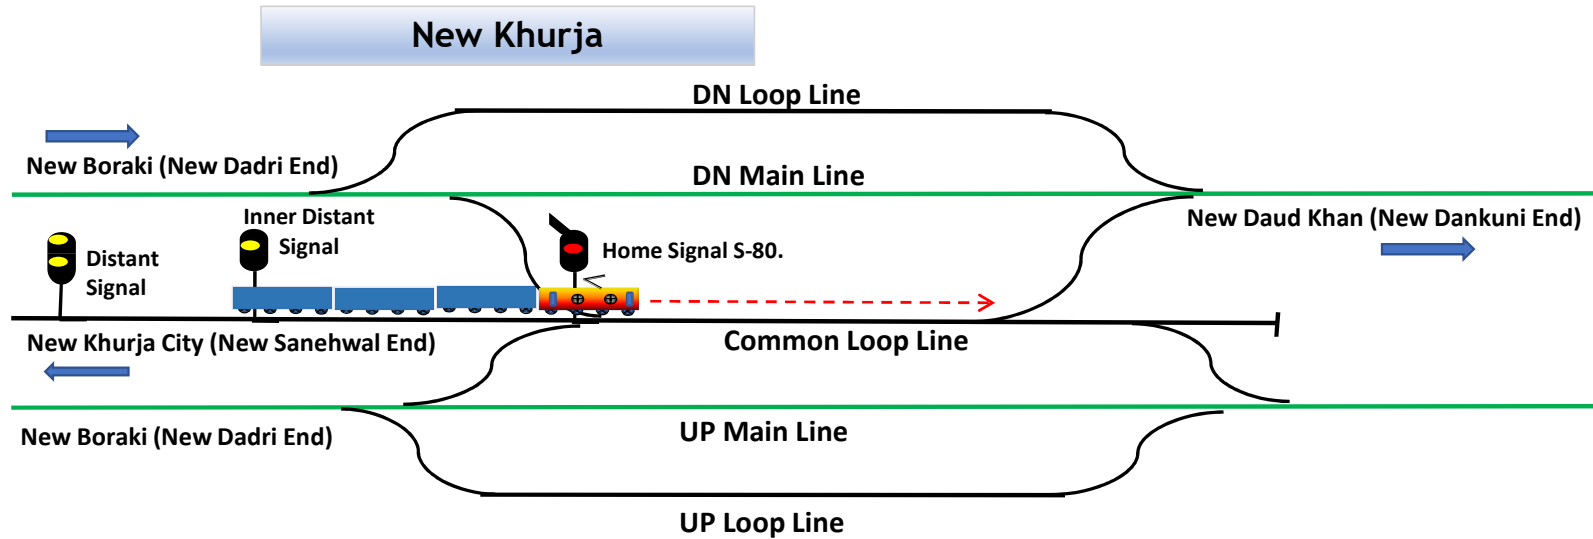
SPAD of DN/KLN load, loco 38060/WAG-9/ASN at New Khurja (DFCC) on 31.05.24

- DN/KLN-66 working with loco 38060/WAG-9/HC/ASN departed from KATN at 17.25 hrs.
- While train was approaching at KRJN Home Signal No. S-80 was Red. LP passed home signal in ON position about half meter ahead of foot of home signal S-80 at 19.56 hrs.
- Fresh crew provided, charge took over at 22.50hrs, left ex site and arrived at 23.27hrs in line no.3 of KRJN.

- Weather and visibility was clear & Visibility of KRJN Home signal no.S-80 clearly visible.
- FSD & VCD was available in Loco and was in working order.

- As per LP, train was controlling with application of RG braking but speed was not reducing, LP applied Emergency Brake from A-9 and ALP also applied RS Valve in Full service but stopped after passing DN Home Signal S-80 about half meter ahead of foot of home signal S-80 as per speed graph.

- As per speed graph at 19.56.07hrs LP applied Emergency brake and train stopped at 19.56.19hrs after travelling 62 meters.
- After passing Yellow aspect, speed was about 30kmph 523meters before Home signal and Home signal S-80 passed about at 12kmph.

D&AR inquiry is under process.

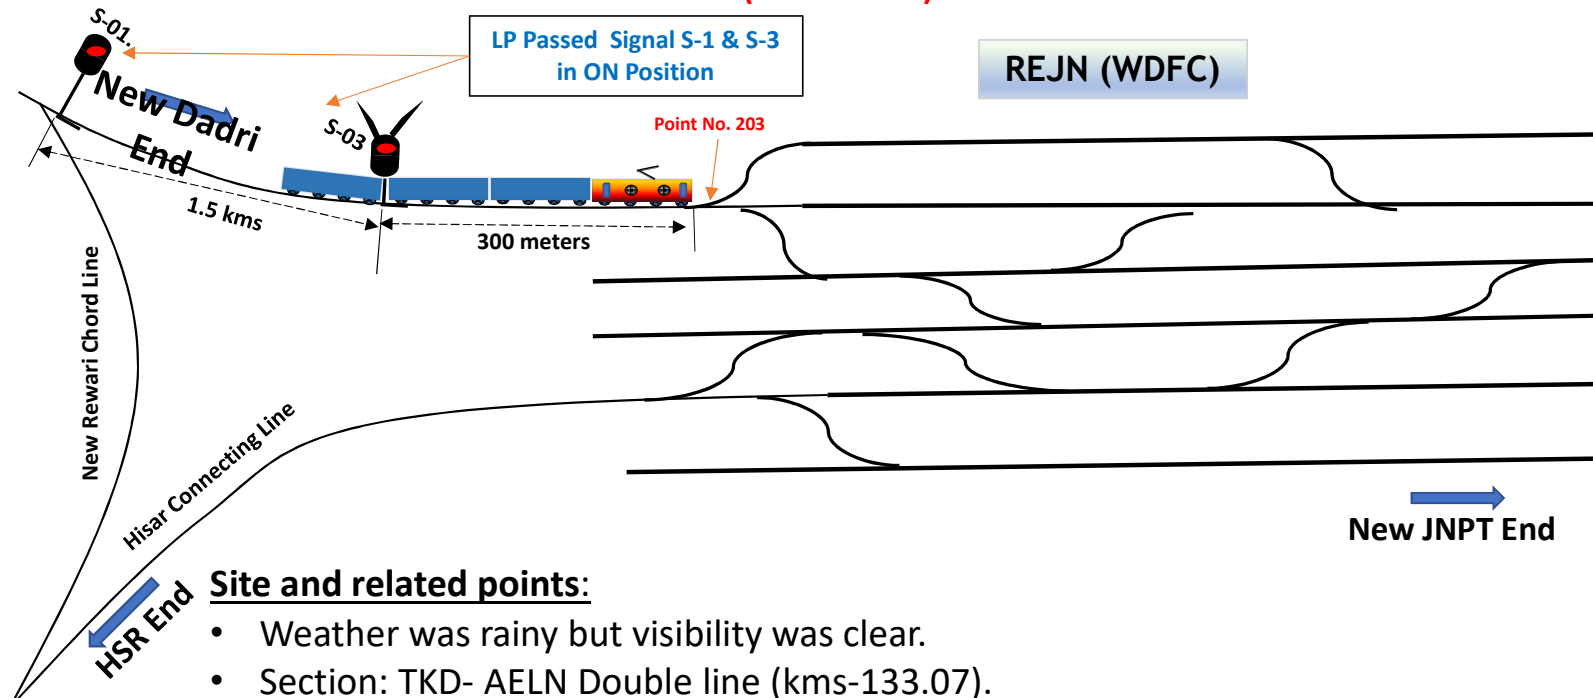
SPAD case of MB/CMLK Load, Loco No. 60446/WAG-12B/NGP at REJN (WDFC) Home signal no.S-1 and S-3 of WDFC section (KRJN-AELN) on 19.09.24

- Weather was rainy but visibility was clear.
- Section: TKD- AELN Double line (kms-133.07).
- Double Distant MACL territory.
- Home signal S-1 is placed at 1335.1kms and S-3 is at 1333.6kms.
- Total duty-**06'42"** at the time of SPAD case and travelled 106kms from TKD to REJN.
- No mandatory course of crew is overdue.
- BPC no.70000043409/CC/dt.24.08.24 issued by DER (ICD)/Dadri/PRYJ/NCR/Twin pipe/(load-42+1=2725T) & no wagon was isolated.
- Last GDR was made at MB on 18.09.2024.
- At 22.06hrs LP Sign ON at TKD of MB/CMLK load, CTO at 22.30hrs and dep. 22:40hrs.

- At 02:52:30 hrs LP was talking on mobile.
- At 02:55 hrs departure of train and LP talking on mobile upto 02:56 hrs.
- Calling out signal was not done by LP & ALP en-route.
- From 04:32:07 to 04:32:19 hrs over speed buzzer reset by LP.
- While passing DHRN station, Horn was blowing (04:40:43 to 04:40:51hrs).
- At 04:46:53, 04:47:00, 04:48:27 hrs, Unclear sound on VHF was observed.
- At 04:48:54 hrs, a voice was heard “CMLK K Chalak Mahodaya baat Karen”.
- At 04:49:09 hrs, a voice was heard “Power Ko Rokiye”.
- At 04:49:09 hrs reaction by LP.
- At 04:49:17 hrs Emergency applied by ALP by RS Valve.
- At 04:52:54 hrs LP mobile’s phone rings.
